TECHNICAL NOTE 3847

FATIGUE-CRACK-PROPAGATION AND RESIDUAL-STATIC-STRENGTH  
RESULTS ON FULL-SCALE TRANSPORT-AIRPLANE WINGS

By Richard E. Whaley, M. J. McGuigan, Jr.,  
and D. F. Bryan

Langley Aeronautical Laboratory  
Langley Field, Va.

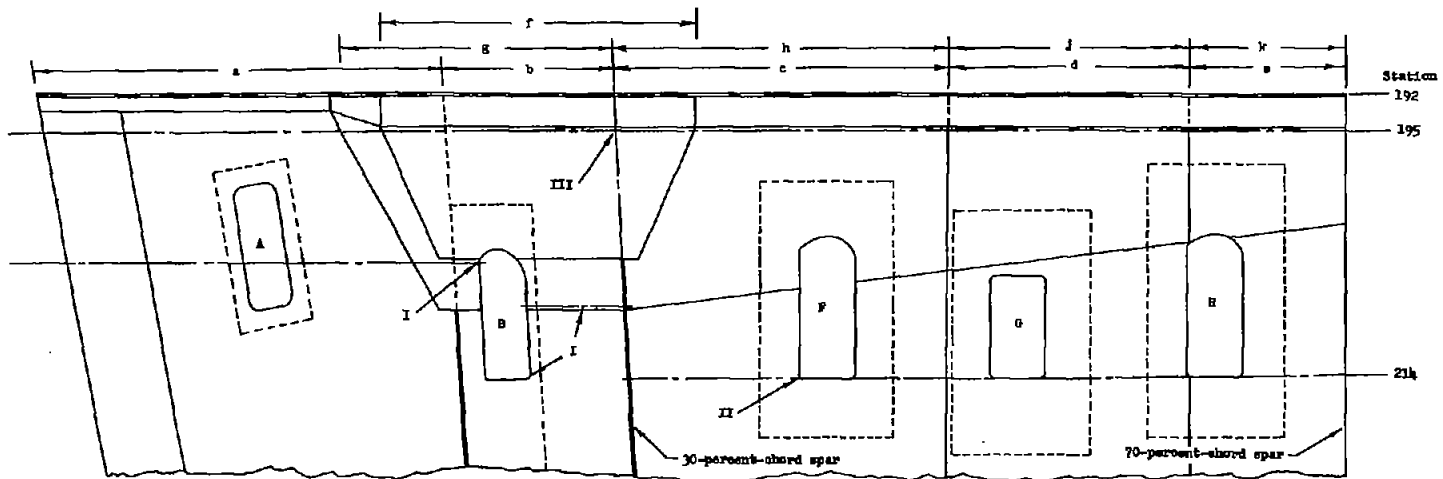
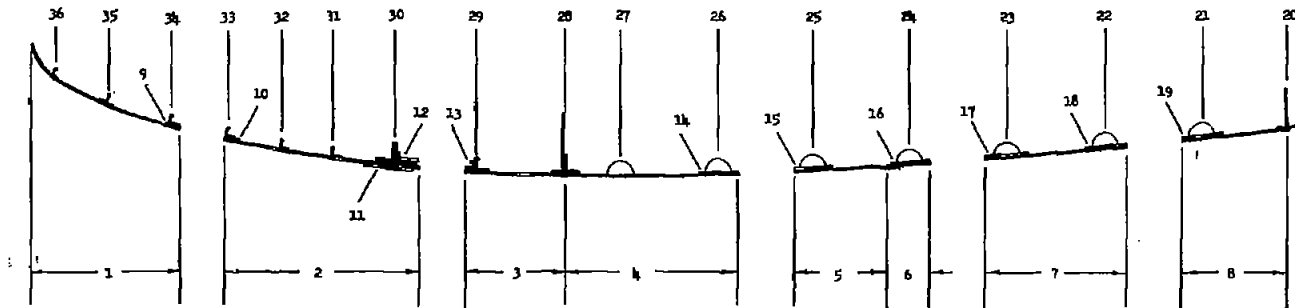
Figure 2.- Details of wing structure and location of failures.

General description of cracks.- All the fatigue cracks that grew until their respective propagation curves indicated that the wing would fail if the test were continued are listed in table II. The cracks occurred at three different locations which are indicated in figure 2 and can be described generally as follows:

Area	Location	Span station
I	Vicinity of cutout B	214
II	Corner of cutout F	214
III	Joggle in doubler	195

Of the 17 cracks reported here, 12 originated in area I, 3 in area II, 1 in area III, and 1 in a machined notch. Nine of the 12 cracks that originated in area I initiated at the edge of the external doubler plate between the 30-percent-chord spar and cutout B. The other three initiated only a few inches away at the outboard rear corner of cutout B. A small crack sometimes originated in the doubler (element 11) in the forward inboard corner of cutout B. This crack never grew until another crack originating in area I progressed to it so both were considered to be in area I. All these cracks progressed through the same elements in approximately the same order.

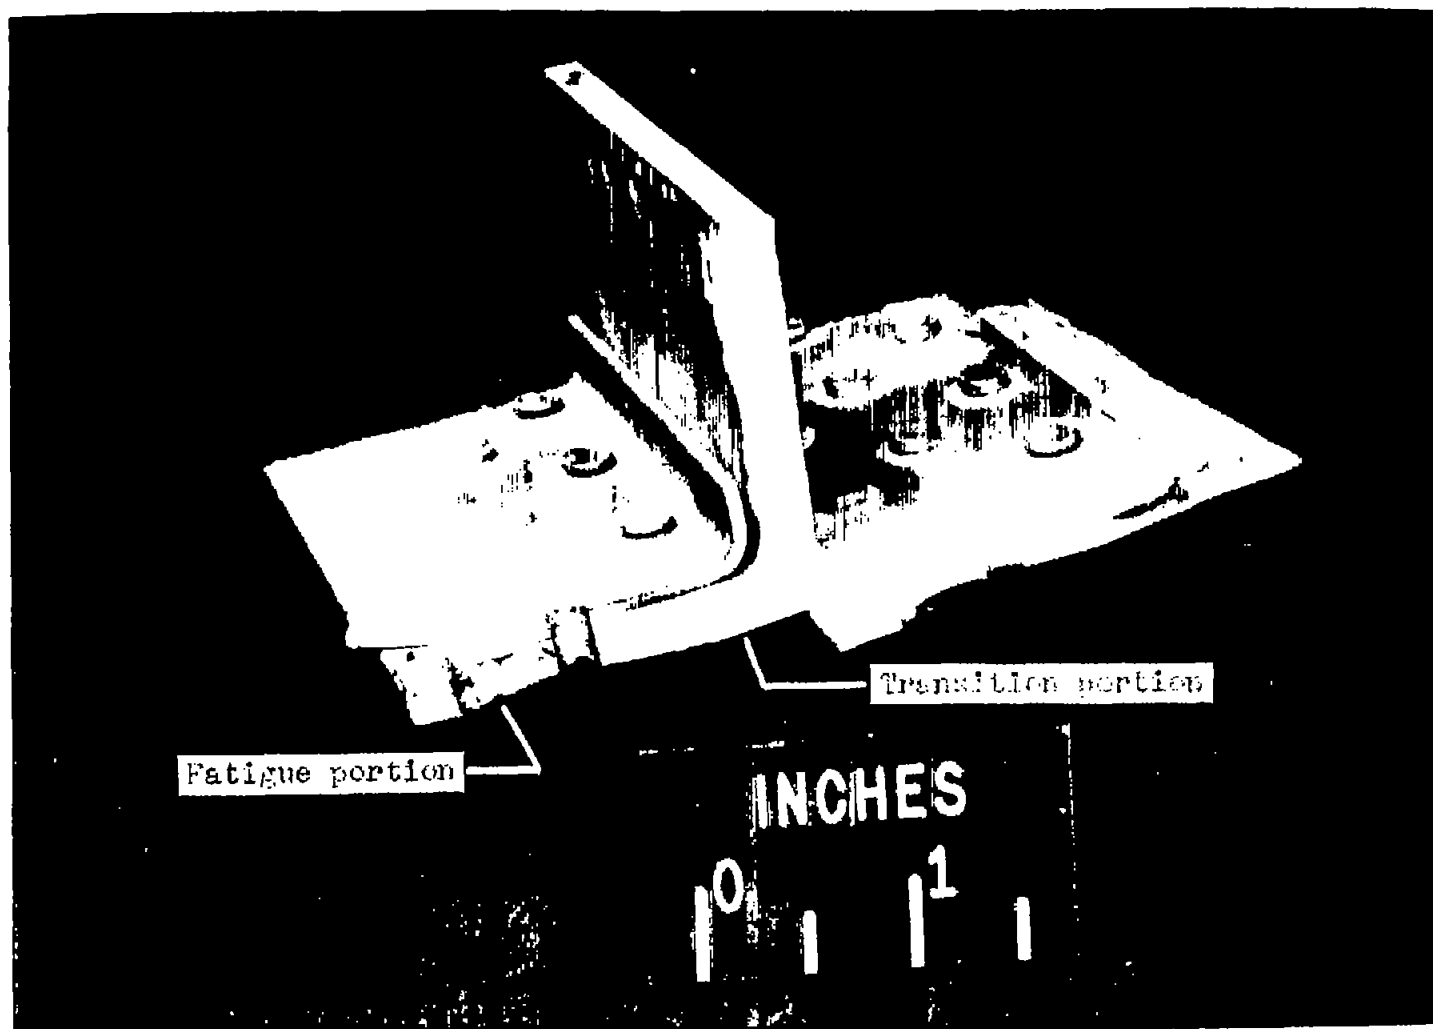
(a) Failure starting as fatigue type and changing to transition type. L-90899.1

Generally, the failure of most of the elements started as a fatigue type and then changed to the transition type. An example of this is shown in figure 16(a). At all load levels after the critical point had been passed, the failures were mostly of the transition type (see fig. 16(b)). For comparative purposes a purely static failure is shown in figure 16(c). Most of the failures did not exhibit all of the identifying characteristics enumerated, and some would be difficult to classify if it were not known beforehand which type of failure had occurred.
